Risk of failure to WABCO Type 12/16 rear brake actuators fitted to Hyundai AT220 buses.

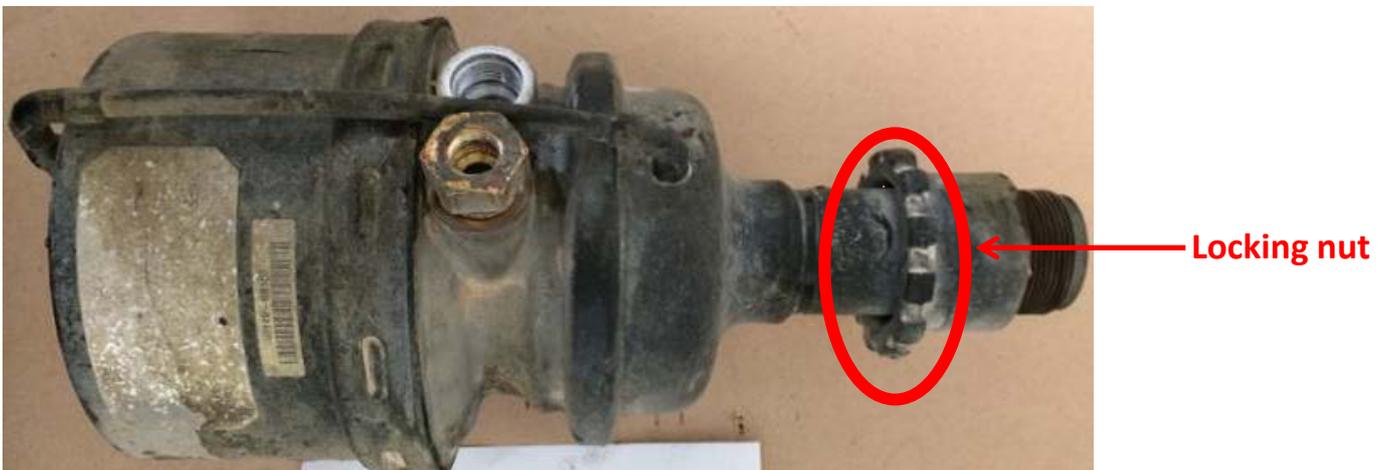
Figure 1 – Affected brake actuator

To date cracks have been located along the threaded section (refer to **figure 2**) of the mounting tube which may be obscured by the locking nut (refer to **figure 1**). It appears that these cracks develop over time.

The NHVR strongly recommends thorough inspection of these actuators to determine if vehicles are affected and that a regime of periodic reinspection be implemented.

It may not be possible to detect initial cracking by visual inspection. Additional non-destructive examination may be required such as dye penetrant and magnaflux inspection. It will be necessary to remove the actuator(s) from the vehicle to perform the inspection.

Cracked actuators should be immediately removed from service as there is no indication at what point the component might fail. Where possible please tag and retain the affected brake actuator(s) as it may be required as part of an investigation into the component by the Commonwealth Department for Infrastructure and Regional Development (DIRD).

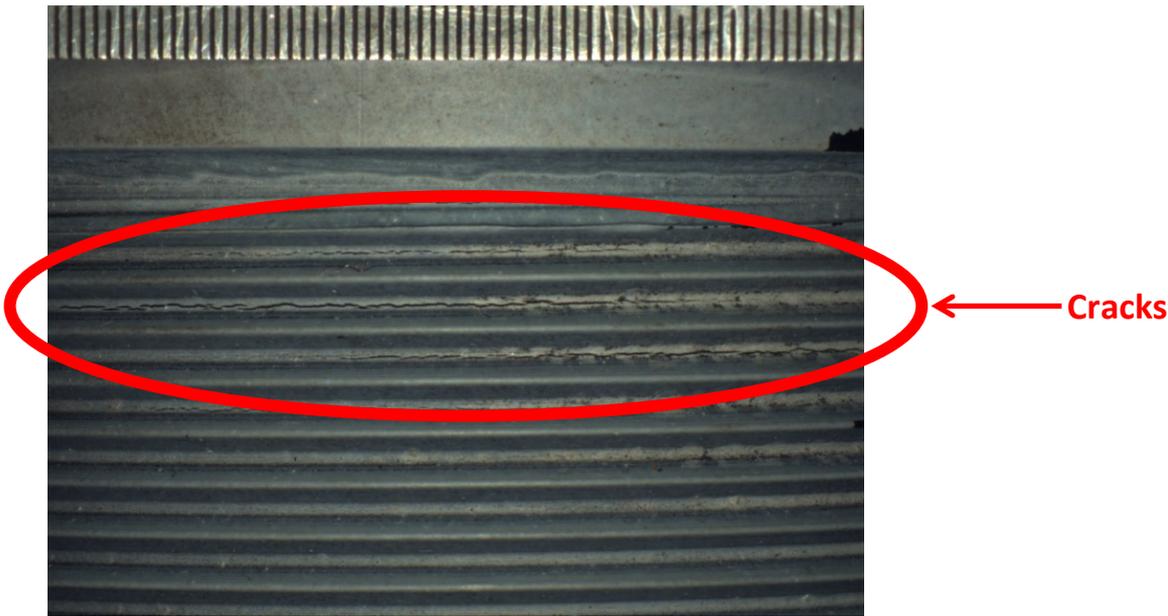
Figure 3 – Cracking at thread root

The National Heavy Vehicle Regulator (NHVR) has received reports that cracks have been identified with several WABCO Type 12/16 brake actuators fitted to the rear of Hyundai AT220 buses. This may result in brake failure with no prior indication to the driver, nor any warning signs which would be likely to be detected during routine maintenance.

The majority of affected vehicles have travelled greater than 90,000 kilometres, however cracks have been identified on a vehicle which had travelled 64,000 kilometres.
